TN-2450 Reset Instruction

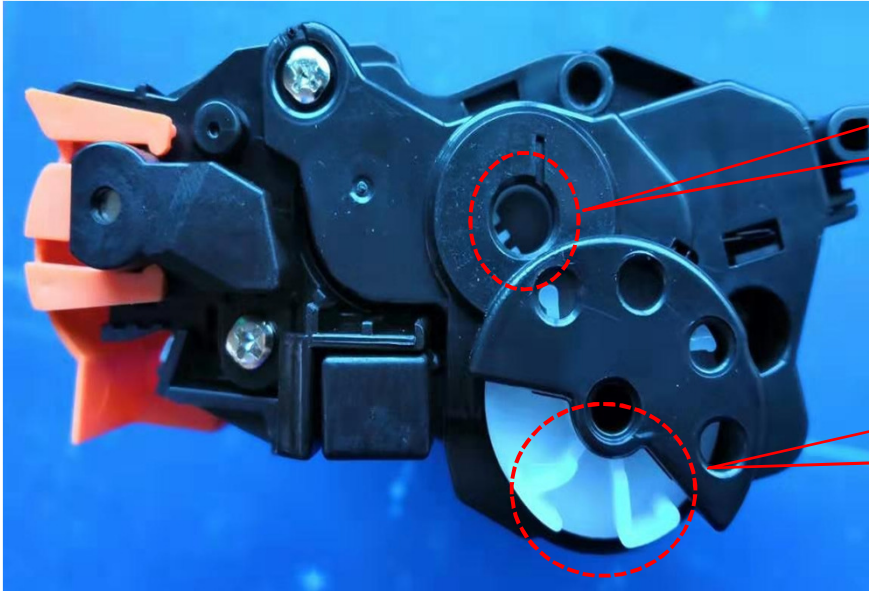
wrong position: tooth shape part is not align with the dented line

gear position not correct

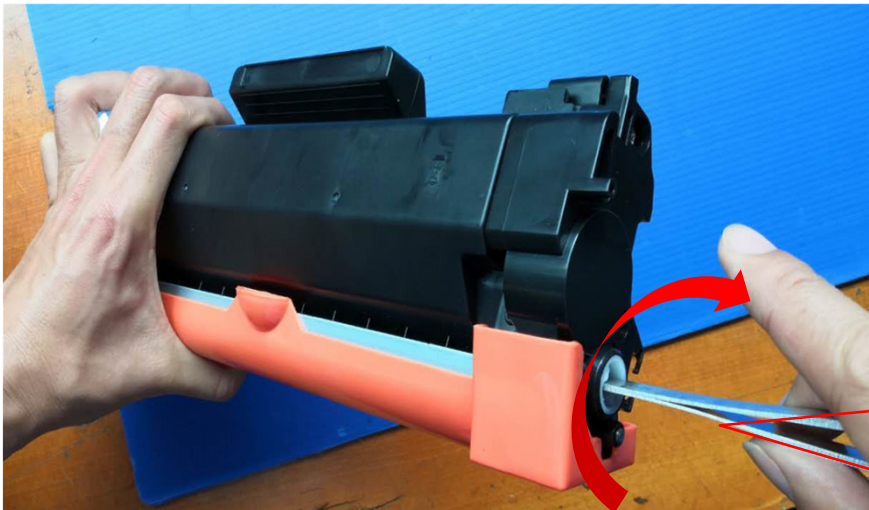
rotate the white gear as the direction of the red arrow until the tooth shape part align with the dented line as in the picture below

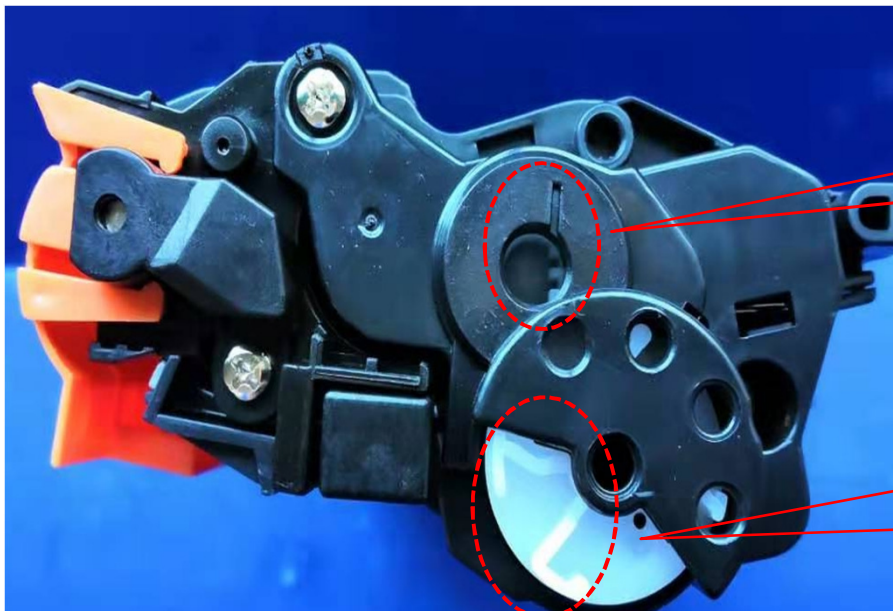
correct position

push the white gear to the right position as in the picture
